EO REPORT ATTACHMENT C
JULY 6, 2007 MEETING
SPRAY IRRIGATION DISPOSAL AREA
ACCESS POINTS AND SIGNAGE PHOTOS

California Utilities Service – Update regarding disposal area access and signage

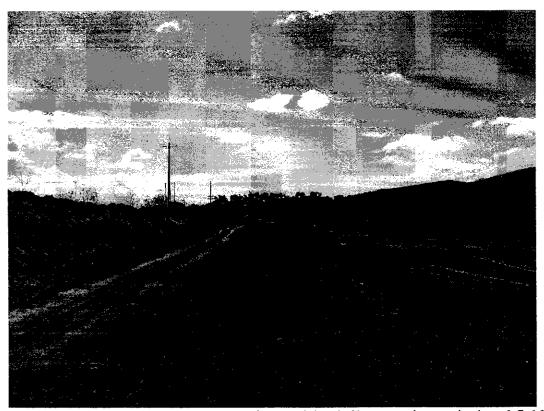
Figure 1: Berm/embankment and service road (on left) separating agricultural field (not seen) from spray irrigation disposal area (on right)

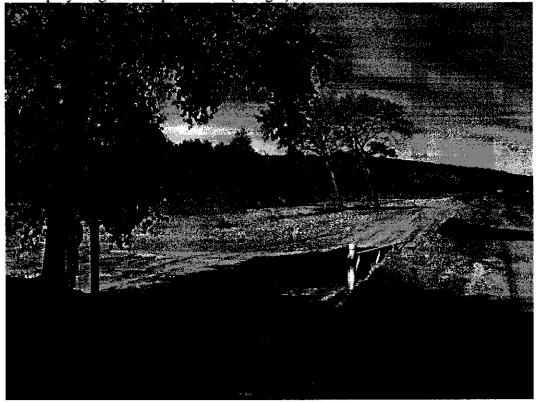
Figure 2: Gated access to disposal area (south from HWY 68); service roads and berm/embankment separating disposal area from agricultural fields (on right)

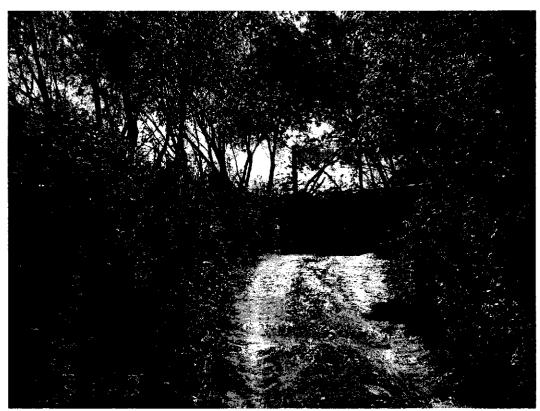
Figure 3: Gated access to disposal area (north from Davis Road)

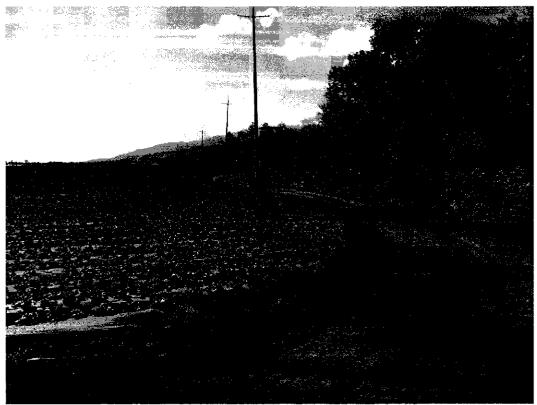
Figure 5: Agricultural service road from Davis Road leading up to disposal area beyond tree line on right

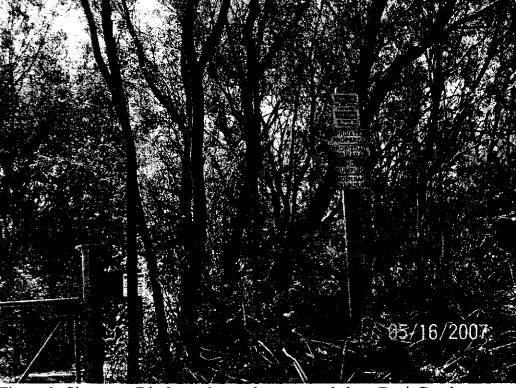
Figure 6: Signage at Discharger's gated access road along Davis Road

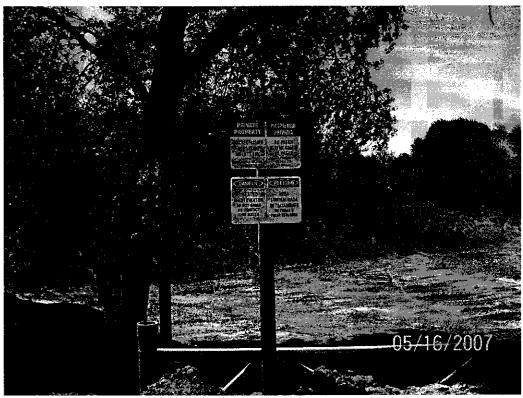
Figure 7: Signage at Discharger's southern (HWY 68) access gate

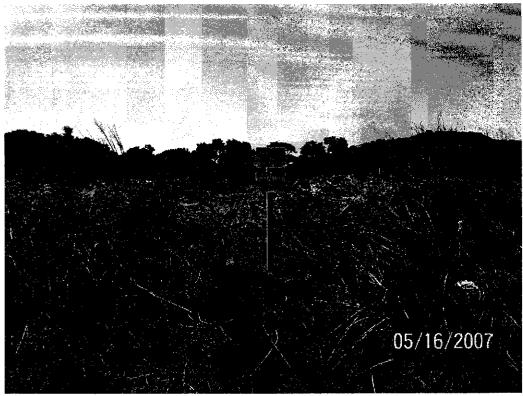
Figure 8: Signage on agricultural service road side of berm/embankment every 500 feet

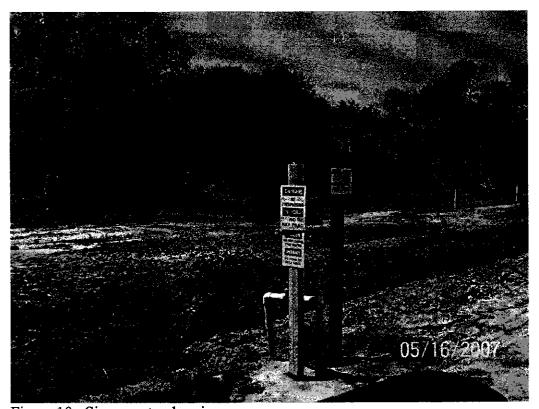
Figure 10: Signage at valve riser

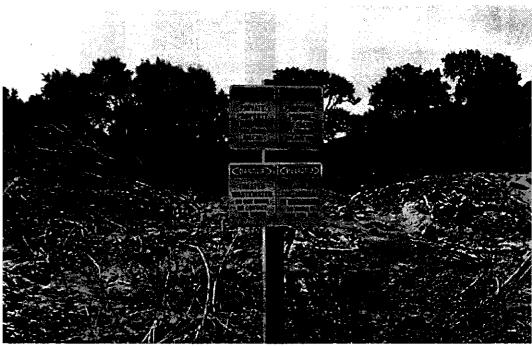
Figure 11: Close up of typical signage along agricultural service road
